INVESTIGATION OF BEHAVIOR OF AN EMBANKMENT

FINAL REPORT

J. Vernon Parcher and T. Allan Haliburton

Oklahoma Research Program
Project No. 71-02-03

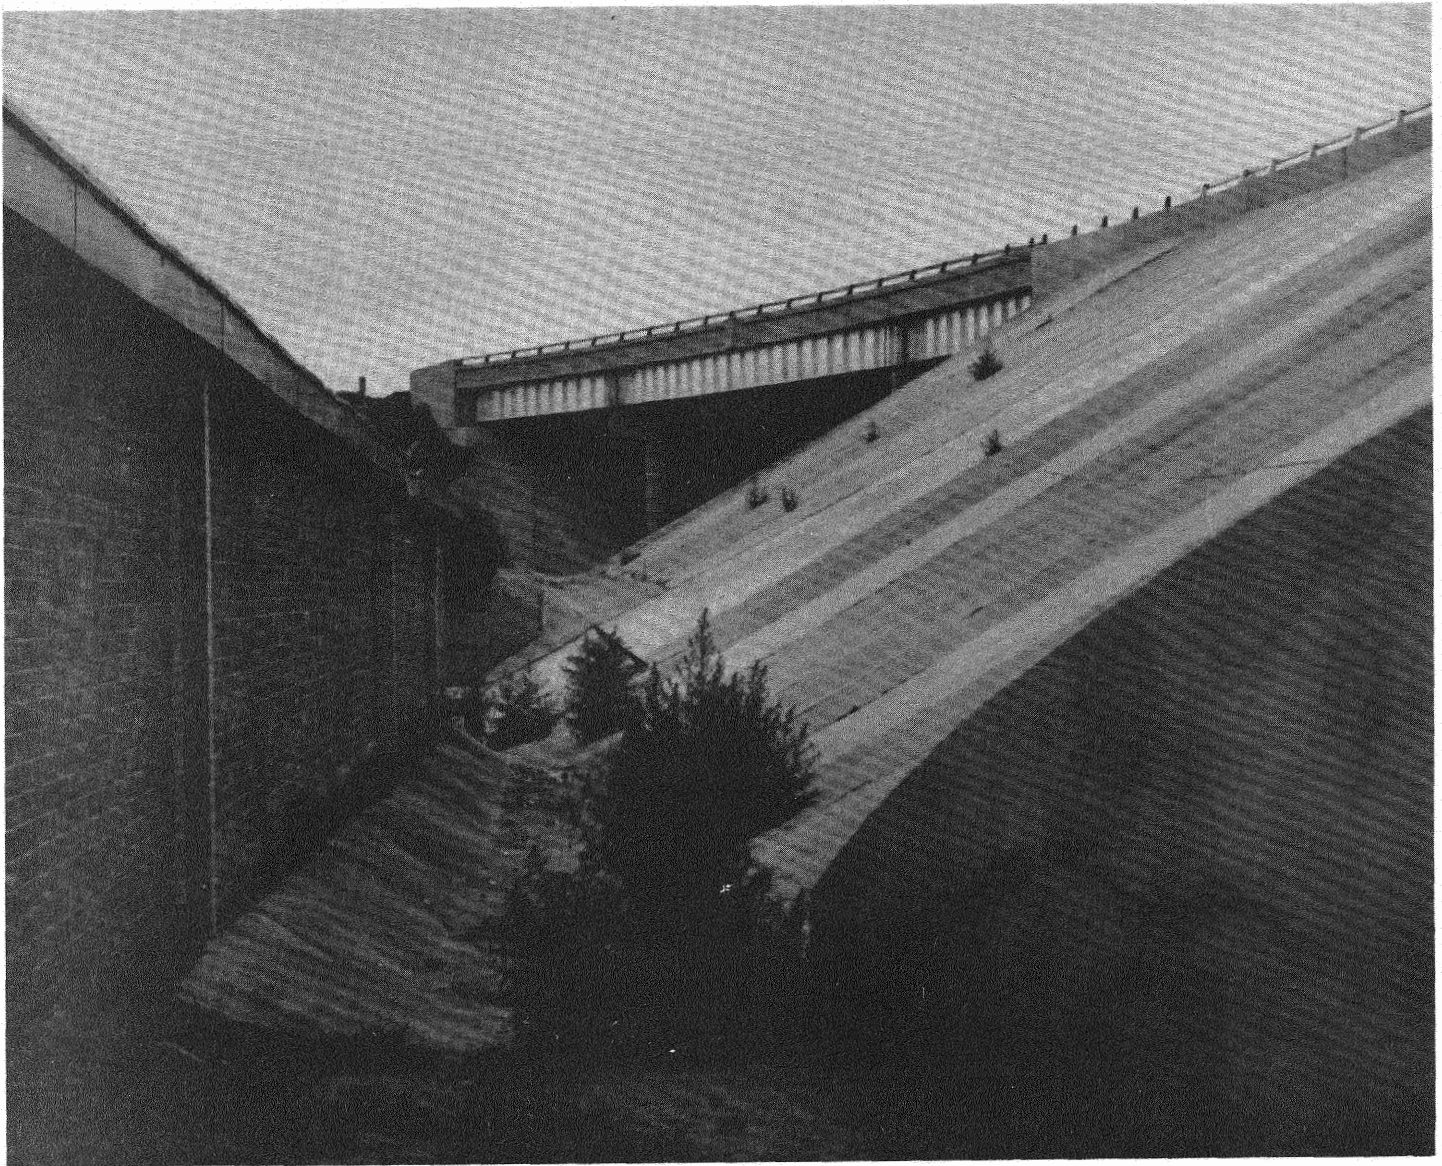
Figure 1. Relationship Between Salvation Army Citadel and OSHD Embankment, Looking West from Ground Level

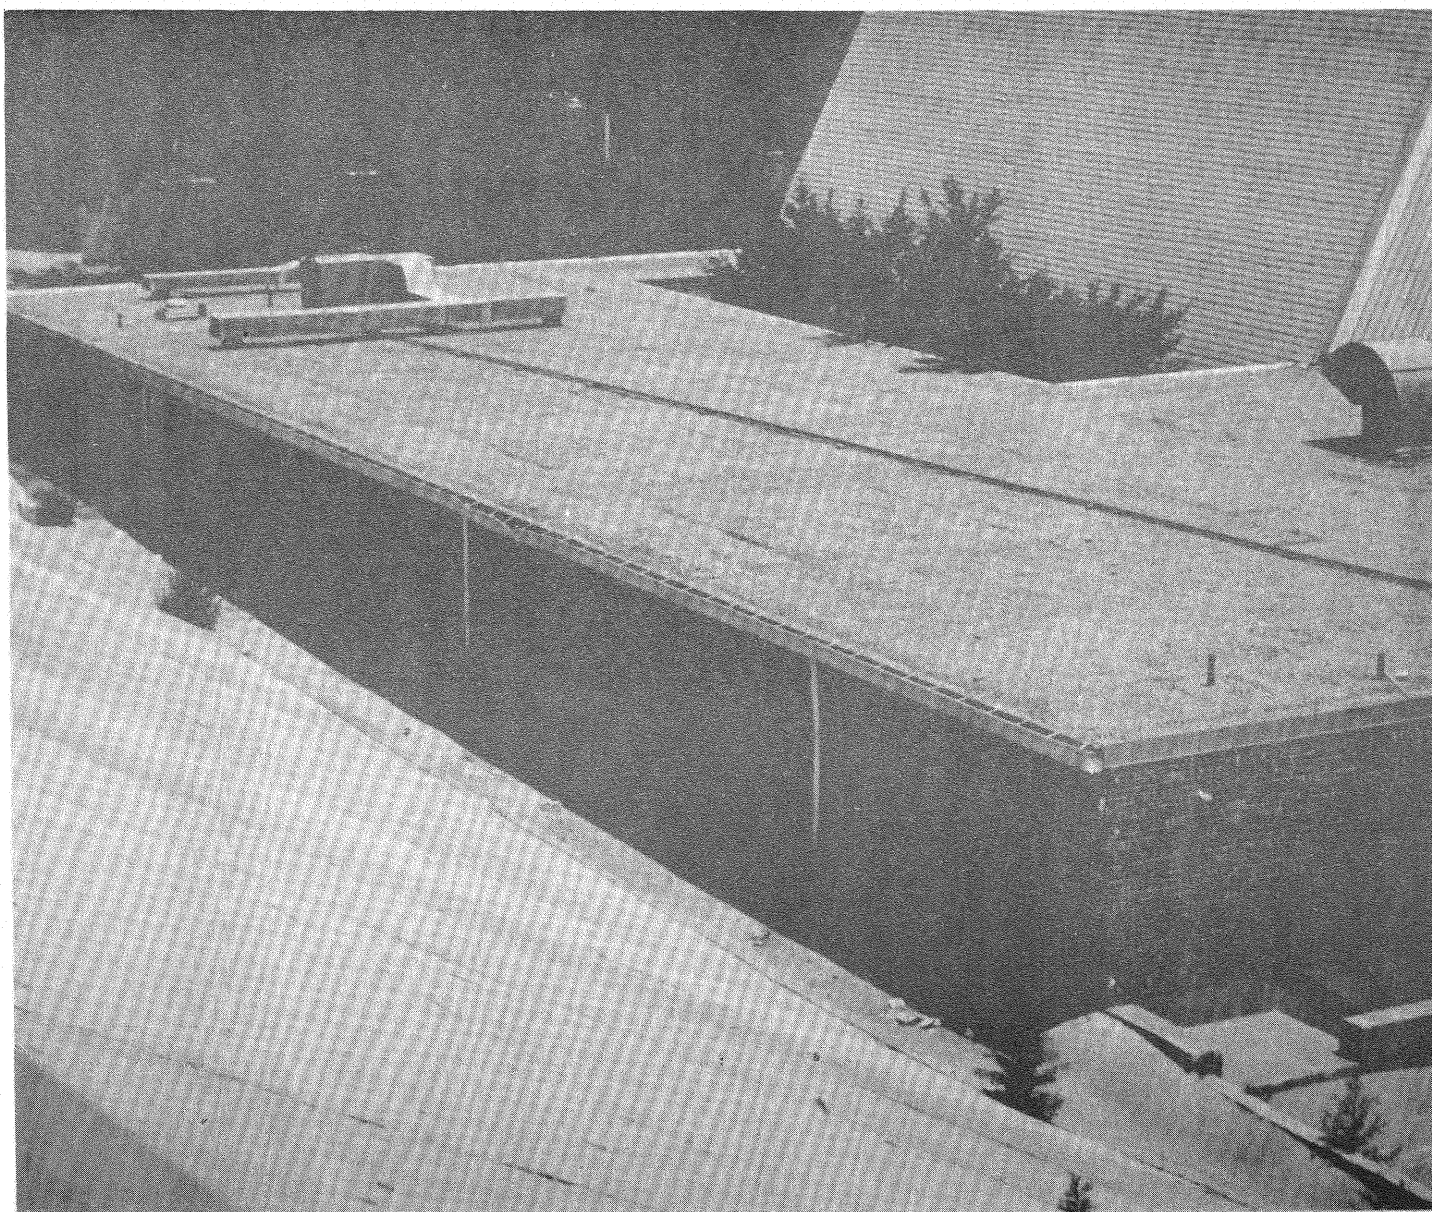
Figure 2. Relationship Between Salvation Army Citadel and OSHD
Embankment, Looking East from Top of Embankment

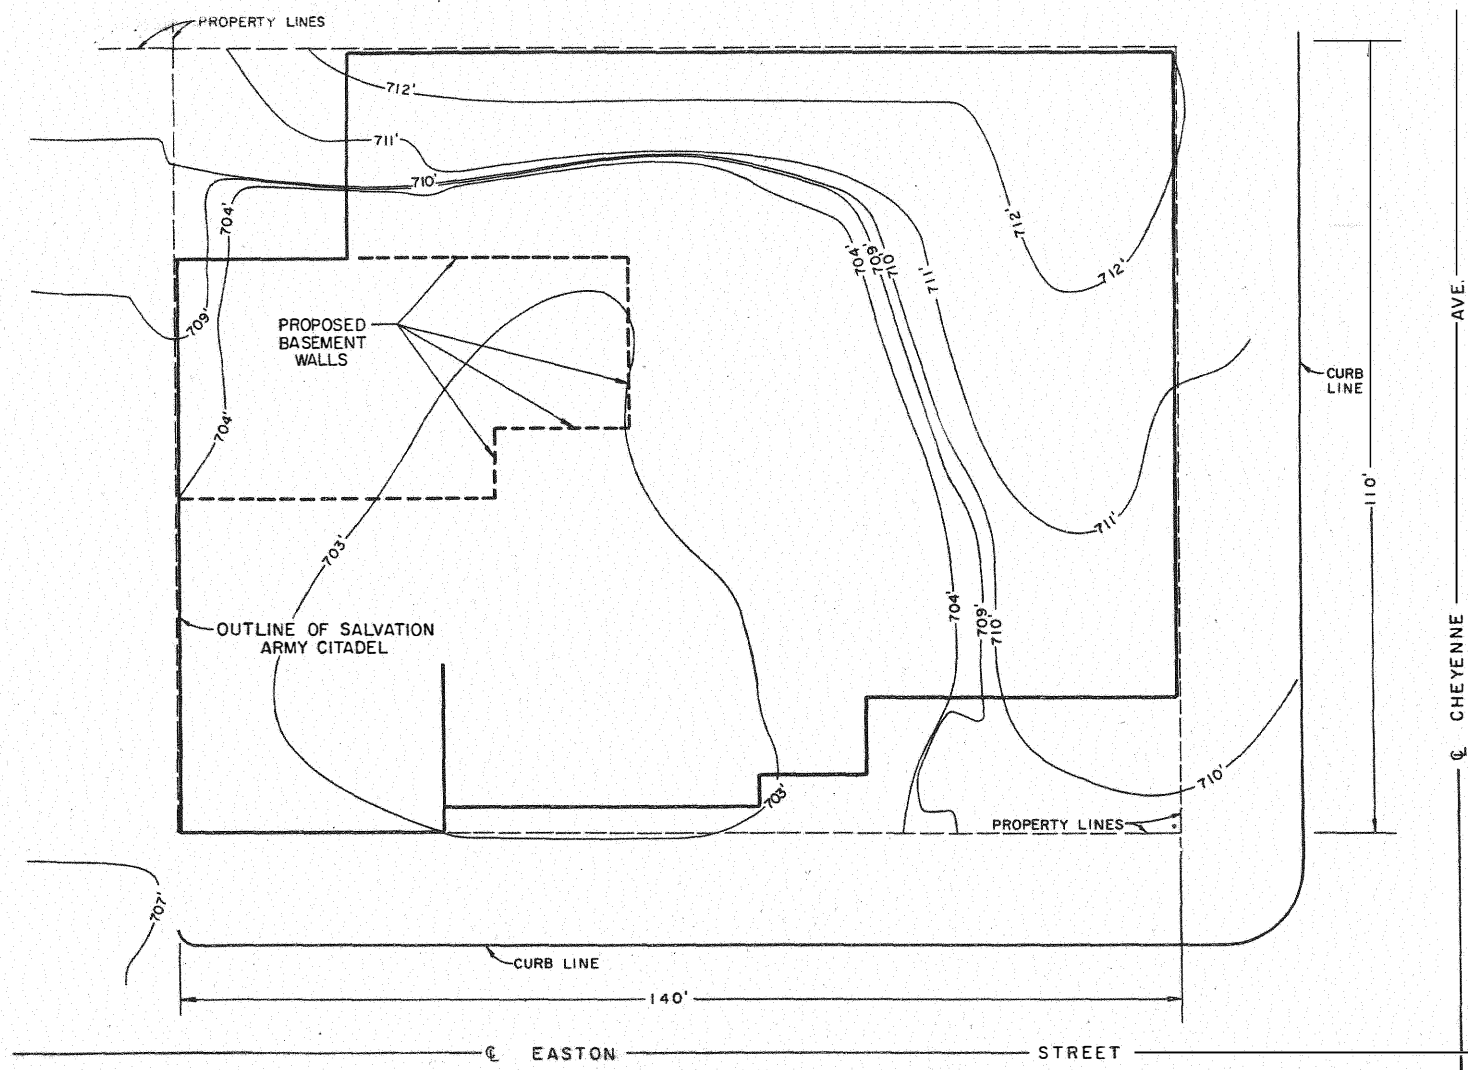
Figure 3. Original Ground Contours at the Salvation Army Citadel Site

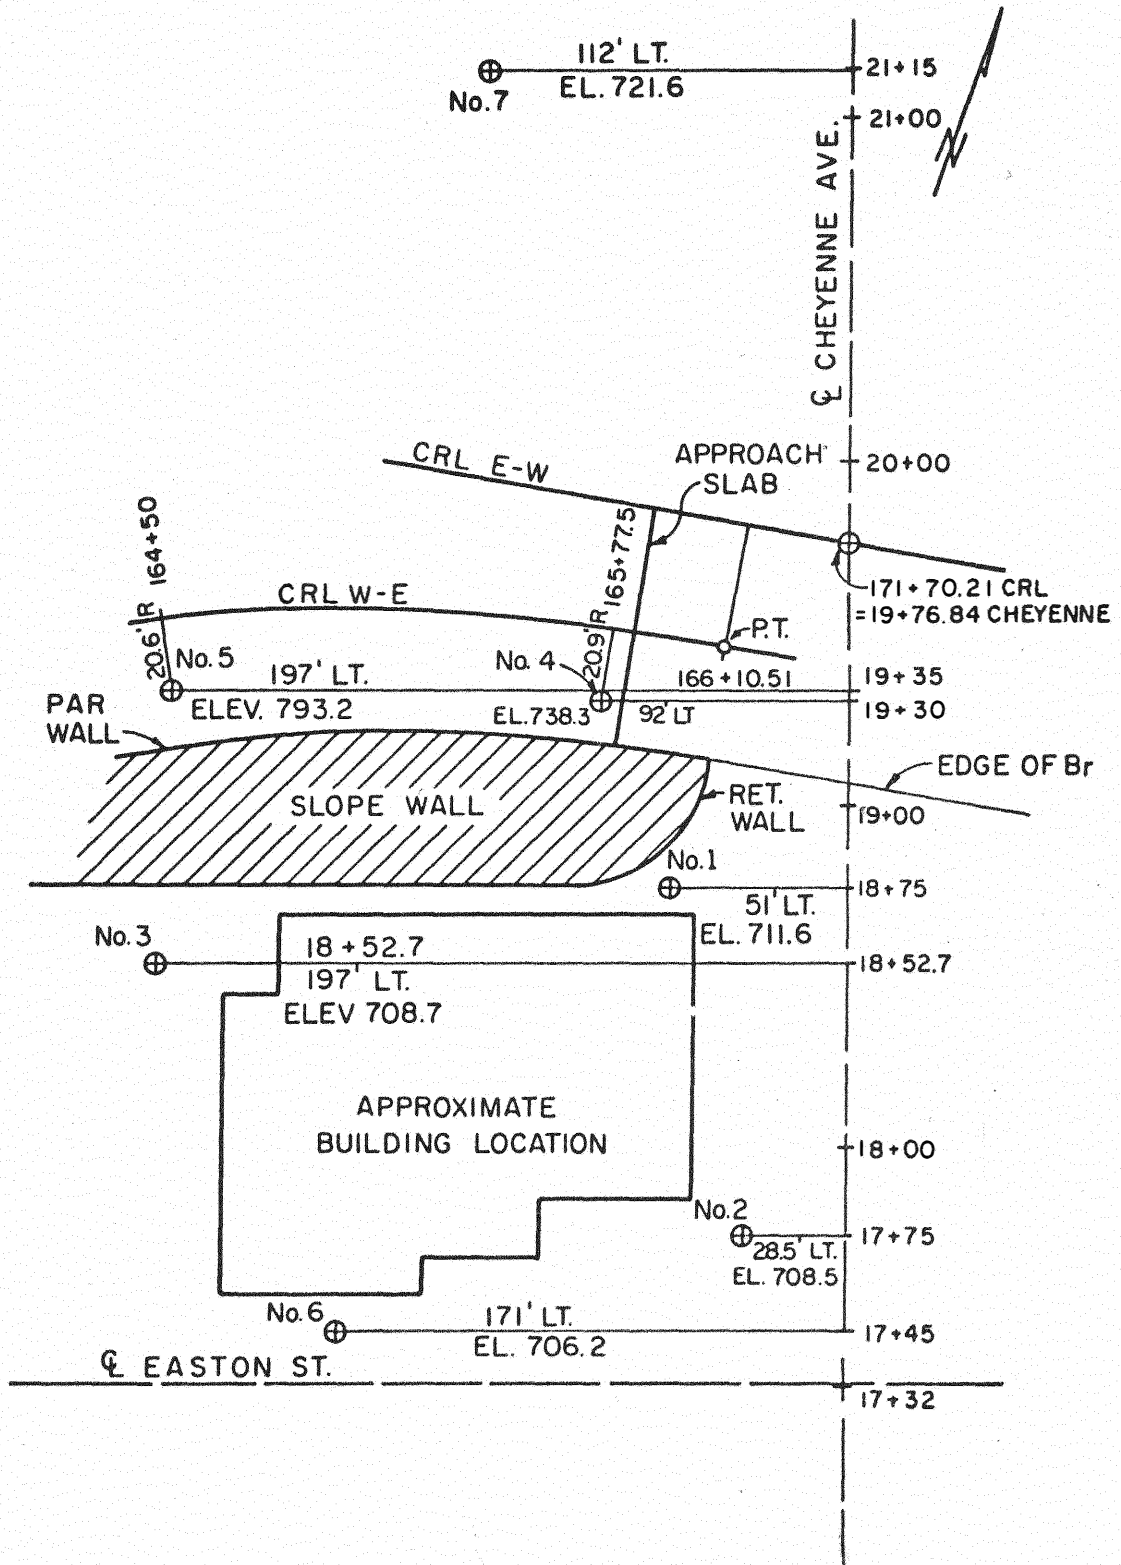
Figure 6. Site Layout and Boring Locations

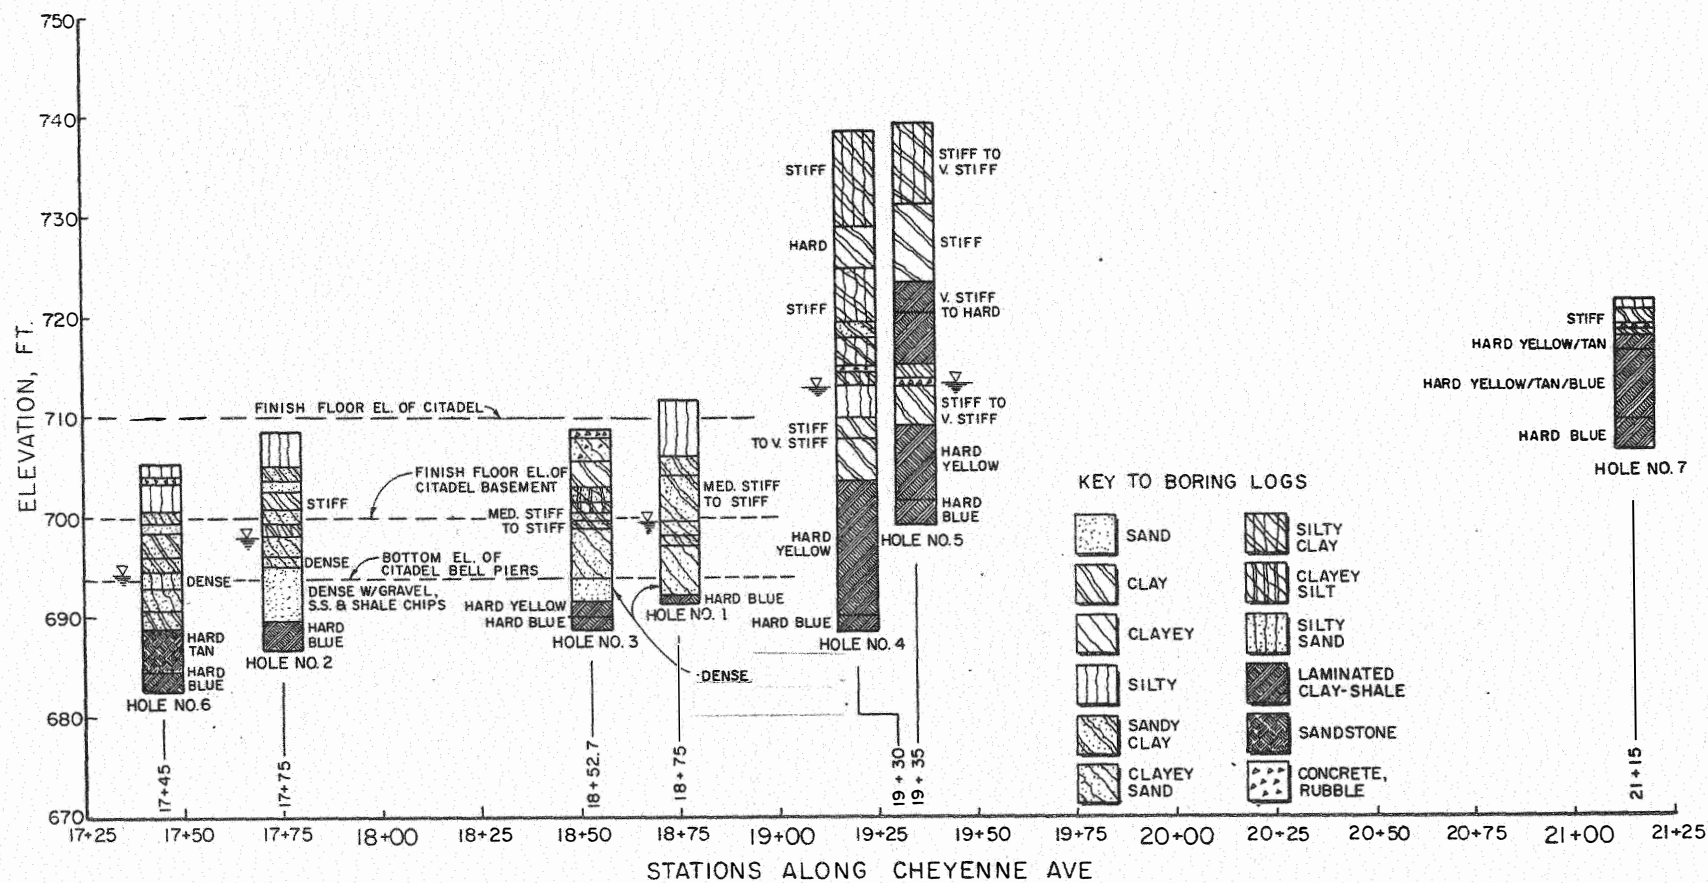
Figure 7. Field Boring Logs, Referenced to Stations Along Cheyenne Avenue

As may be noted from the boring logs of Figs 7 and 8, the fill is composed primarily of stiff to very stiff, yellow and yellow/tan, silty shaley compacted clay. The fill material was probably obtained

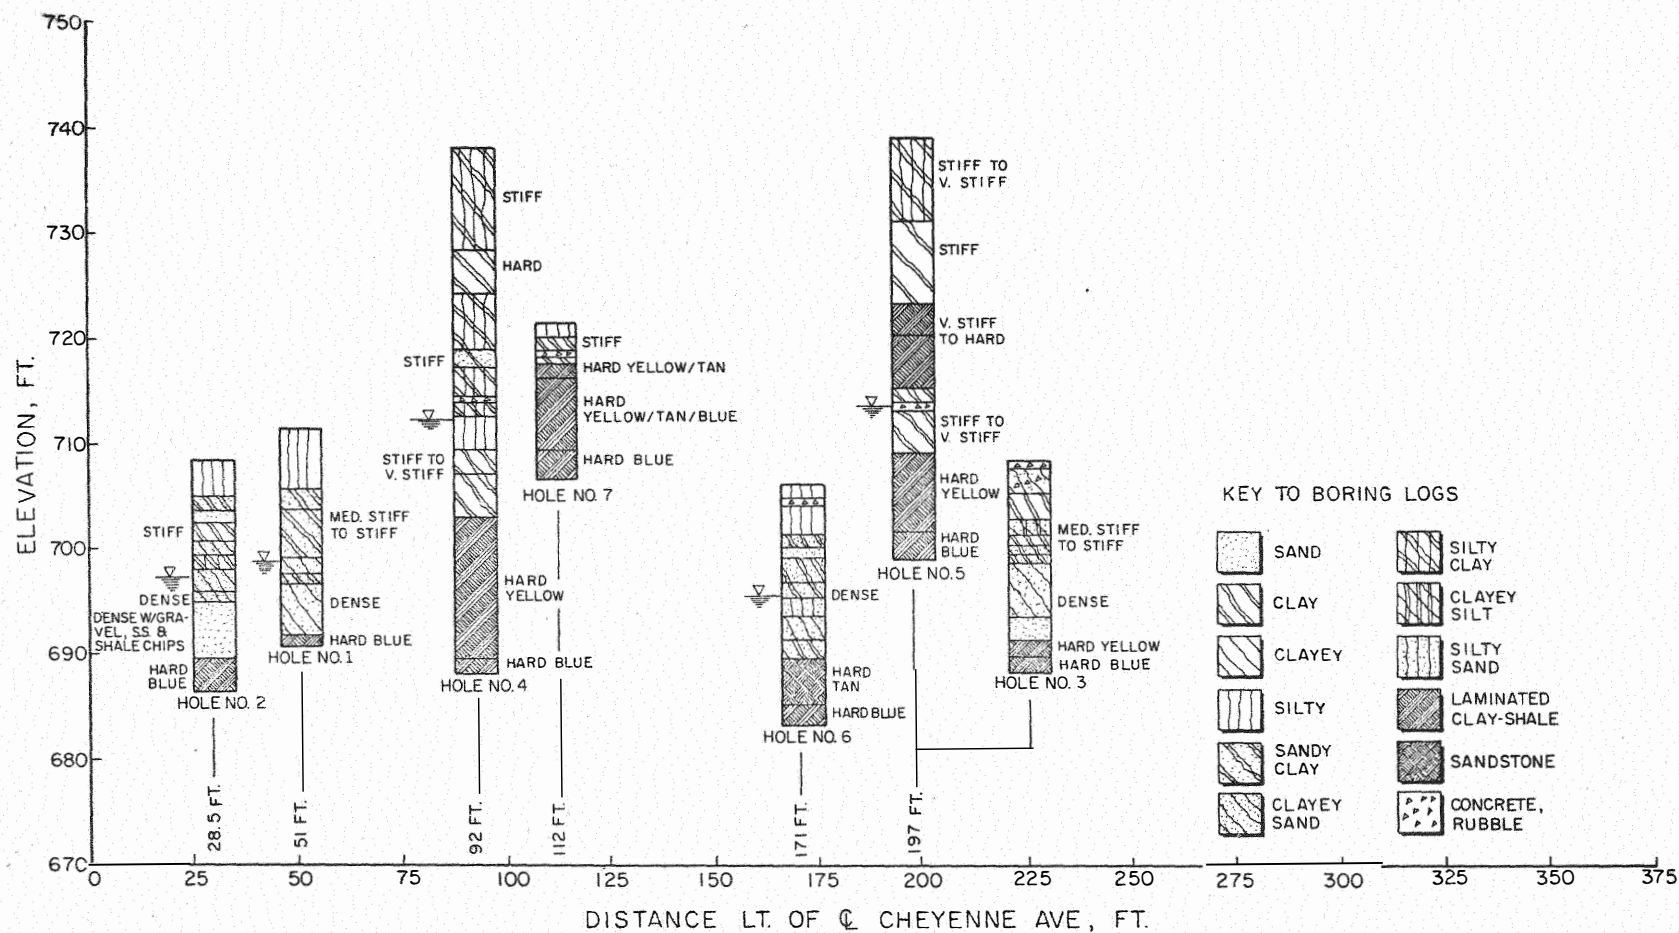
Figure 8. Field Boring Logs, Referenced to Distance Left of Cheyenne Avenue

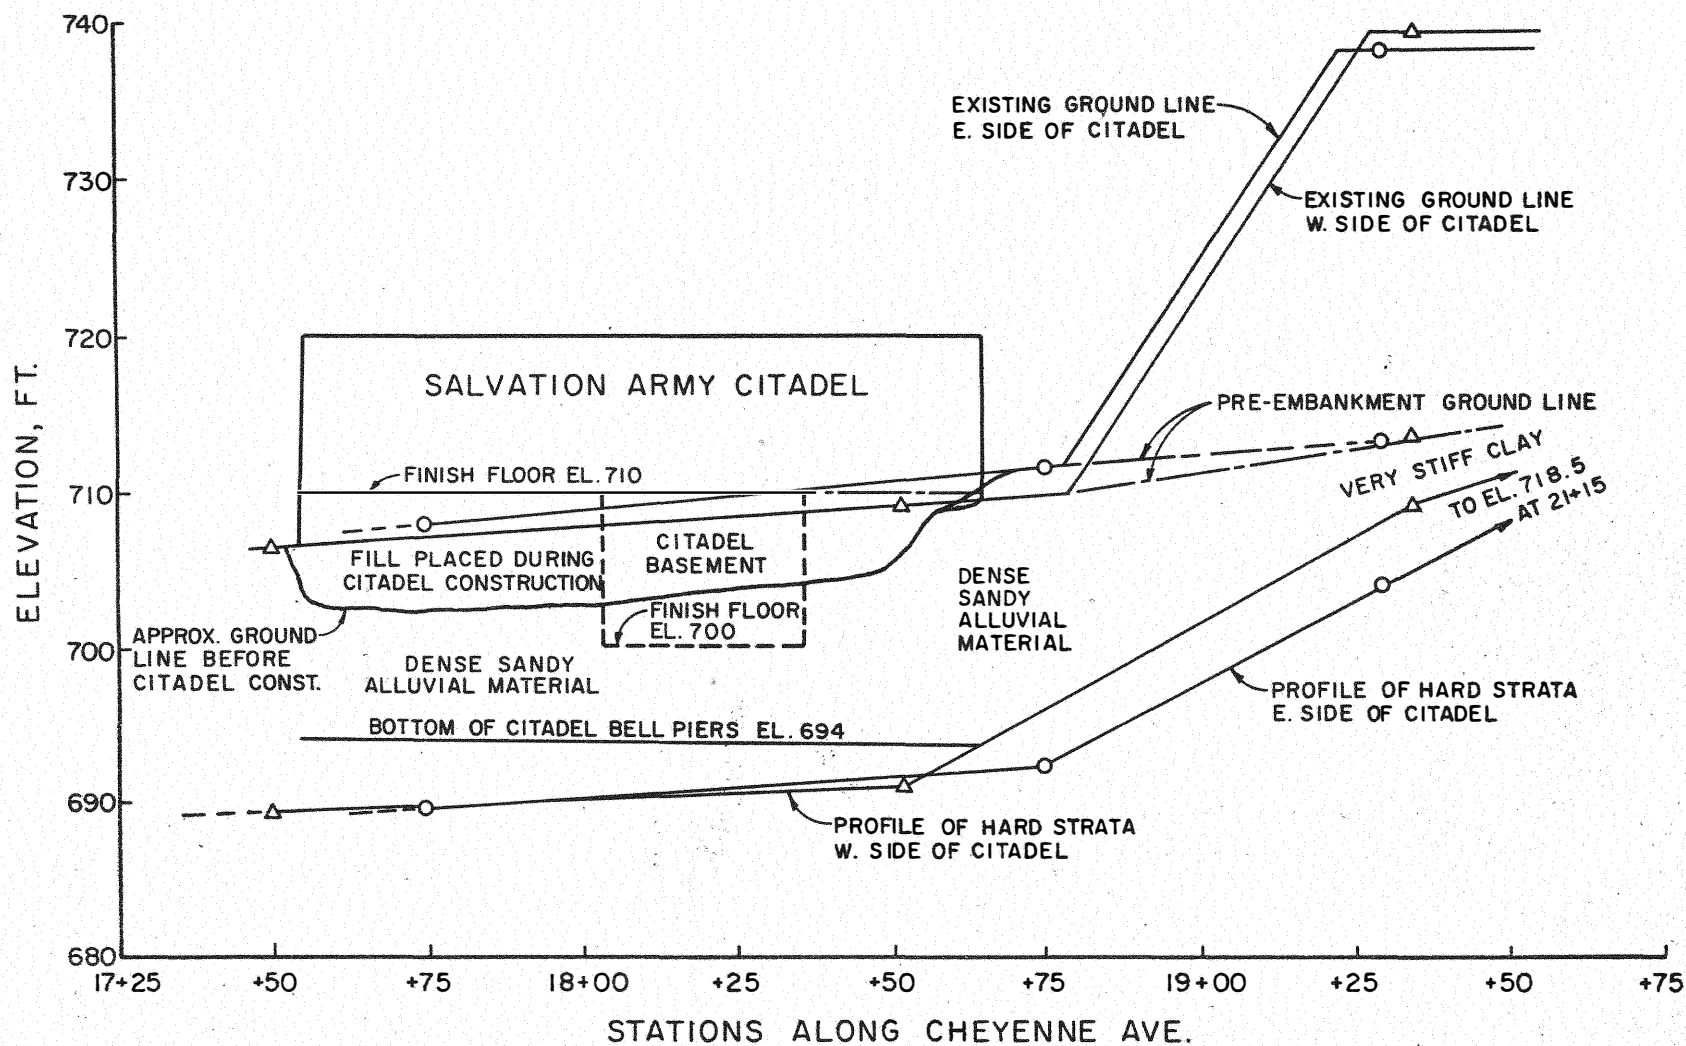
While no borings were made through the south slope of the embankment, inspection of soil borings at the toe and crest plus the profile of Fig 9 leads to the conclusion that the south slope rests partly on stiff to hard laminated clays and clay-shales (noted in Borings No. 4 and 5) and partly on dense sandy material (noted in Borings No. 1 and 3). If anything, the sandy material located under the south slope should be denser than that found in the old stream channel; its location at the stream edge would have subjected it to more cycles of flooding and drying.

Figure 9. North-South Profile Under Citadel and Embankment
